FURTHER FATIGUE TESTING OF A GLASS FIBER REINFORCED PLASTIC GLIDER WING

by C.A.Patching and L.A.Wood, The Sir Lawrence Wackett Centre for Aerospace Design Technology, Royal Melbourne Institute of Technology, Melbourne, Australia.
Presented to the XXV OSTIV Congress, St Auban, France, July, 1997.

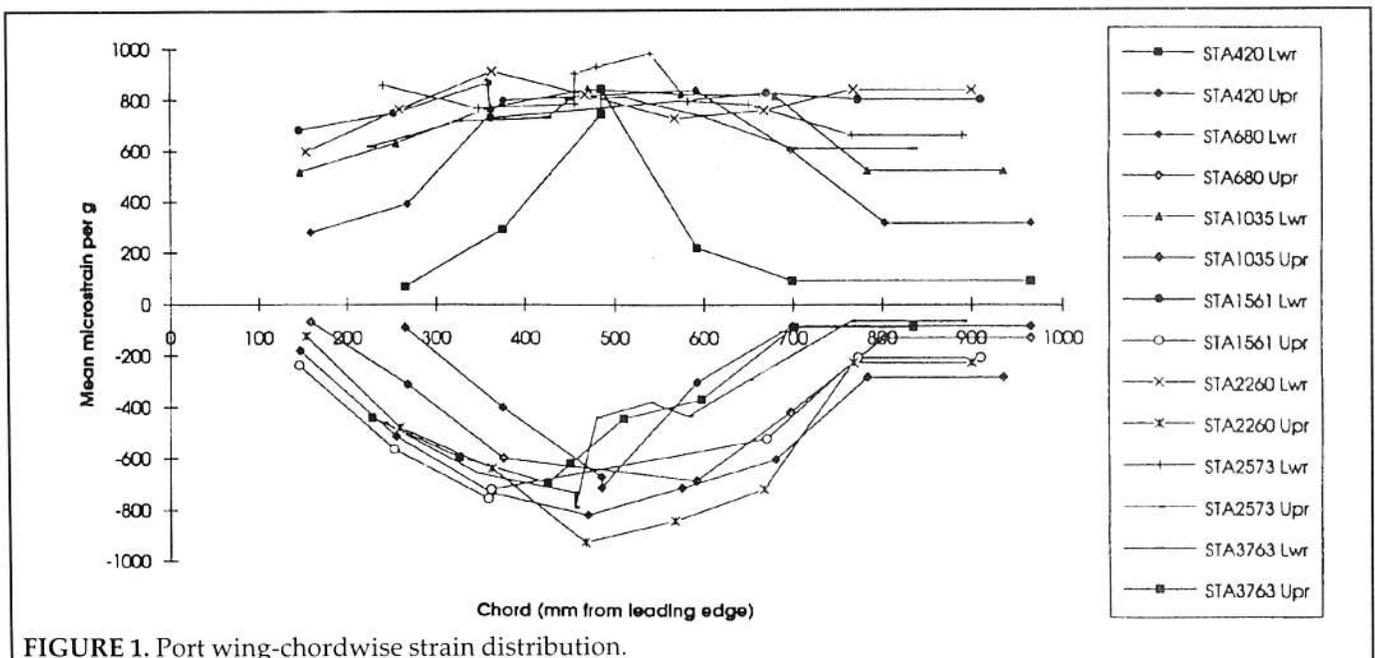
FIGURE 1. Port wing-chordwise strain distribution.

An area of delamination was detected between the starboard upper skin and the main spar boom at 35,482 hours. The delamination extended from Sta.4,480 to 4,590 and was about 8mm in width. Figure 1 shows that the strain in the upper spar boom was approximately 600 microstrain per g.

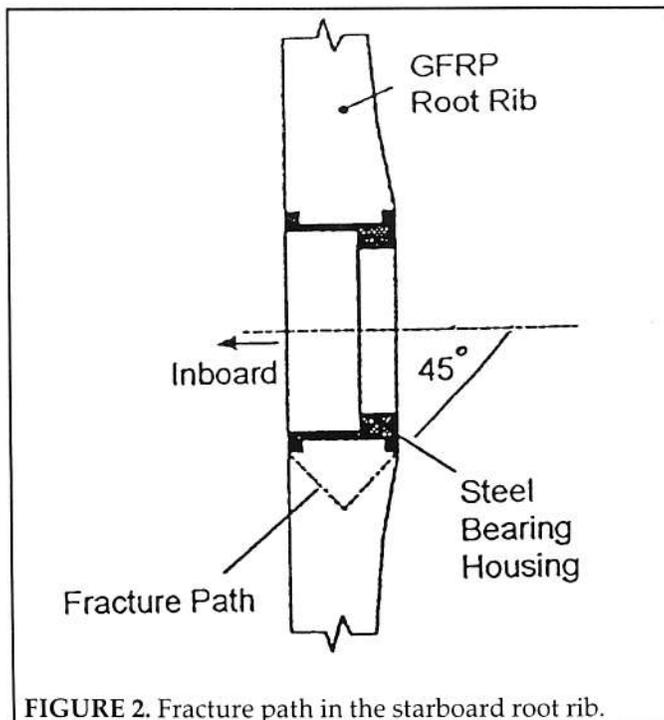
FIGURE 2. Fracture path in the starboard root rib.

3. The bond between each housing and rib had failed as evidenced by the presence of a 'fretting' compound at the interface.
4. The amount of delamination in the rib material was minimal and the fracture at each housing had followed a line from each surface of the rib at about 45° to the axis of the housing as shown in Figure 2 around the lower half of the housing.

6. The detection of delamination and its growth during testing, together with other evidence including rubbing damage to the fracture surfaces, all indicated that the failure mode was fatigue. A possible reason for the limited damage growth was that the rovings introduced in Repair Scheme No. 2 had constrained the propaga-

The front bearing when tilted introduced a more severe loading condition in the root rib, subsequently it was likely that it failed first, closely followed by the rear bearing as the load was transferred. The fatigue test lives for the first reported detection of failure in the root rib at each of the bearings and when repairs were made are given in Table 2.

The wing was repaired by completely removing the damaged rib and replacing it with one manufactured during 1992 by Schempp-Hirth. The wing was taken from the test rig for this repair. A separate investigation was conducted into the fatigue life of the root rib material when subjected to bearing loads. The preliminary results of these tests given in Reference 6, indicated that bearing failure due to fatigue load occurred after a similar number of simulated flying hours to those which caused failure in the full scale fatigue test.
