Fatigue of Composite Scarf Joints in Wind Energy Rotor Blades and in Spar Beams for Light Aircraft

Presented at the XXIX OSTIV Congress, Luesse-Berlin, Germany, 6 August – 13 August 2008

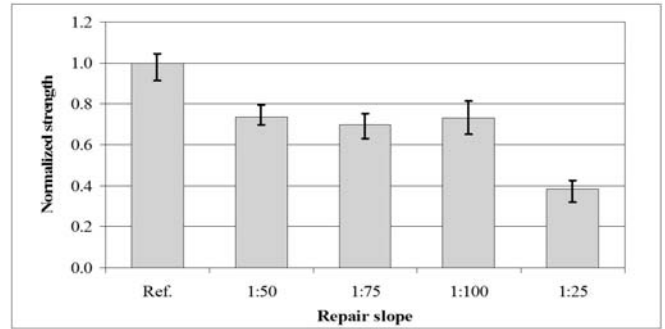
Figure 3 Effect of the slope for scarf repairs on static strength (Repair at 2/3 H).

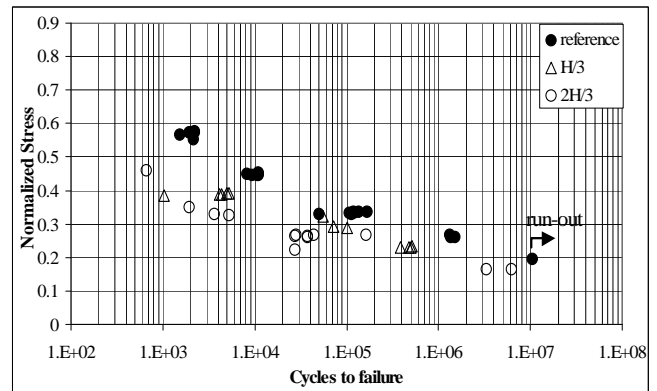
Figure 4 Fatigue results for different repair depth (scarf repair with slope 1:50).

For the fatigue tests, scarf repairs with a slope of 1:50 were used based on the results of the static tests. Fatigue results for the first material alternative are presented in Fig. 4 for both repair depths studied. The experimental data show that the repair affects the slope of the S/N line, since at higher fatigue cycles both reference and repair coupons are quite close. Obviously the S/N curve for the repaired coupons lies lower than that of the reference since, during static experiments, the strength of the repaired coupons was

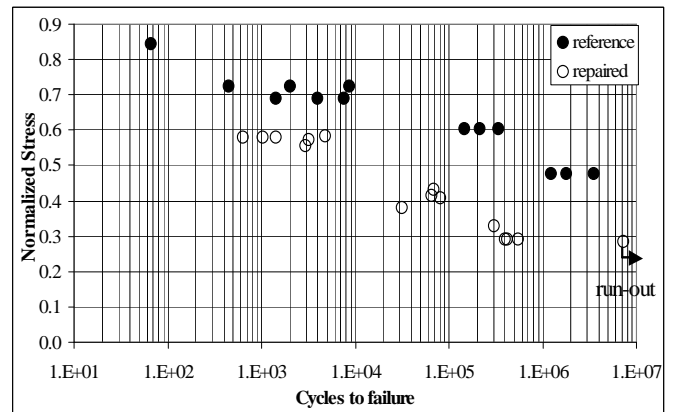
Figure 5 Fatigue results of alternative material (scarf repair slope 1:50, repair depth 2/3 H).

Experimental data from the fatigue tests of coupons from the second repair variant are shown in Fig. 5. For this case, the slope of the S/N curve seems also to be affected by the repair, but exactly opposite than for the former material, with the differences being larger for higher number of cycles. One repaired coupon sustained more than 7 million cycles without breaking and therefore was marked accordingly on the graph.

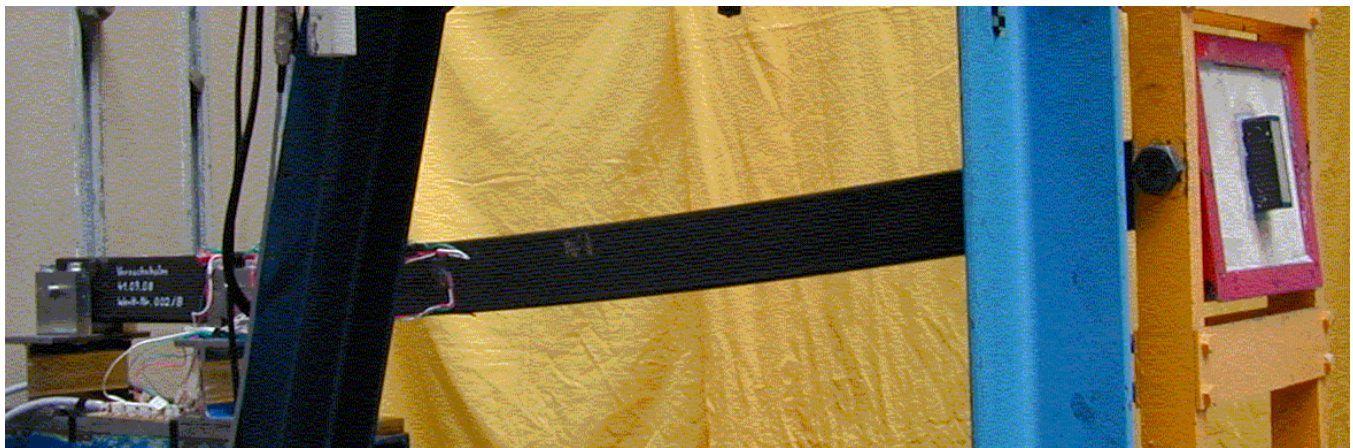
Figure 7 CFRP-spar in test bench at maximum load.

The spar beam with the geometry as described above was exposed to a constant amplitude fatigue test. The stress ratio was $R = -0.55$. This stress ratio applies also for the KoSMOS load spectra developed for light aircraft and sailplanes⁹. Therefore, possible damages from spectra tests are anticipated at maximum loads to develop similar to those in the one-step fatigue test. The fatigue tests for both load spectra and one-step fatigue tests were carried out displacement-controlled. The maximum compression strain in the upper spar cap was minus 0.5%. The location of the maximum strain was the measurement cross section which was outfitted with strain gauges at the spar cap and the shear webs. The testing frequency was 0.4 Hz. In Fig. 7 the spar beam is shown at maximum load in the test bench.

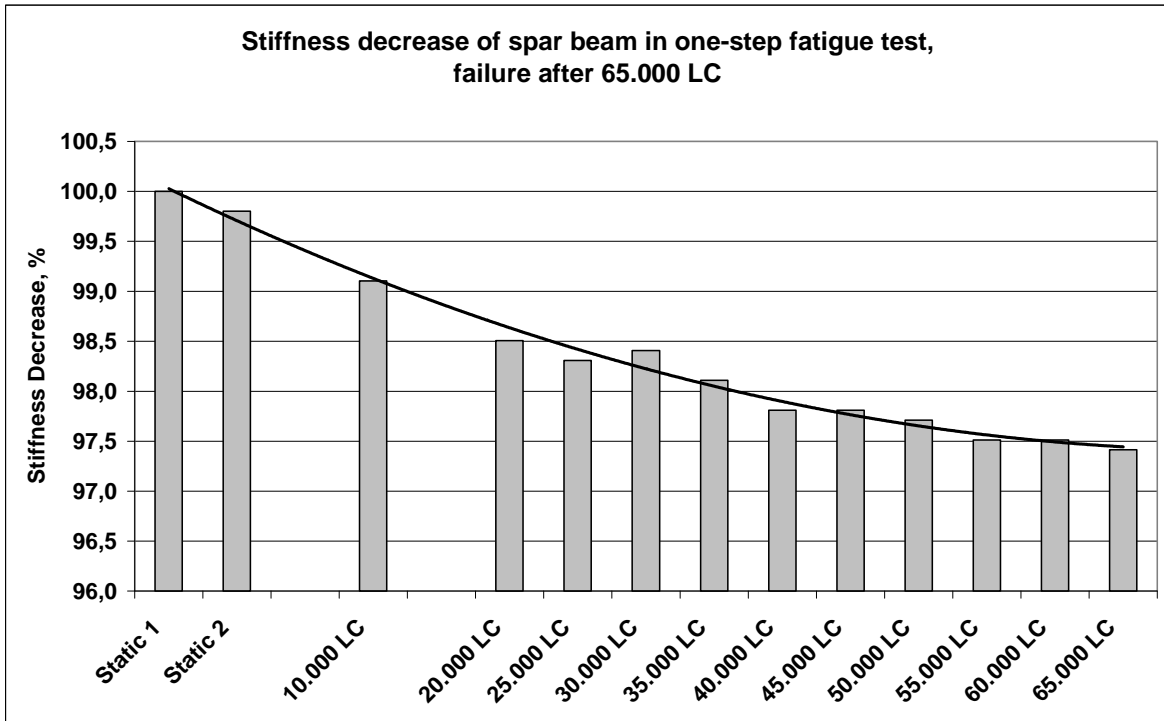
Figure 10 Stiffness change versus load cycle numbers.

The only significant degradation during the life of these three spar beams was observed by means of stiffness checks at certain time intervals. The degradation of the stiffness was evaluated by means of the global increase of deflection at the loaded ends. The results are presented in Fig. 10 for the beam with the constant amplitude test and in Fig. 11 for one of the two beams tested with KoSMOS.

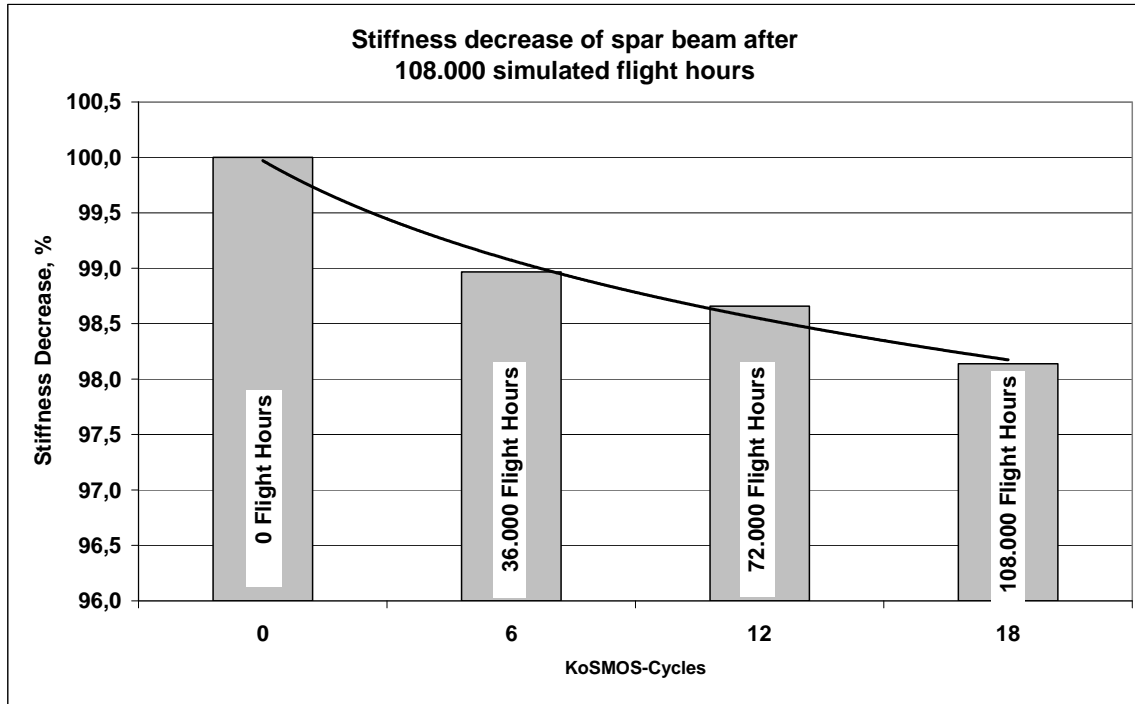
Figure 11 Stiffness change versus KoSMOS-cycles.
